MERRIMAN DAM

PHASE I INSPECTION REPORT

NATIONAL DAM SAFETY PROGRAM.

Merriman Dam (NY 00121). Hudson River Valley, Roundout Creek, Ulster County, New York. Phase I Inspection Report.

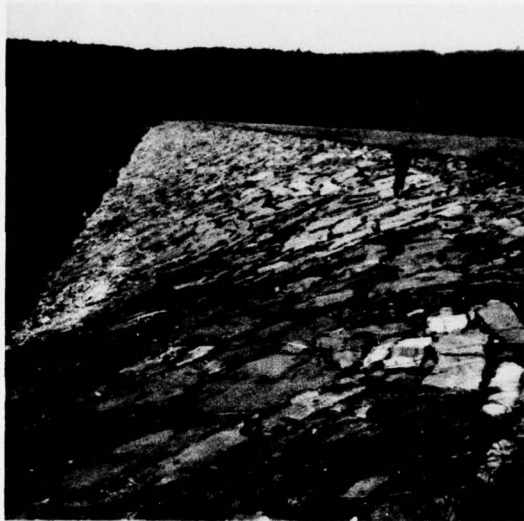
UPSTREAM FACE OF DAM

d. Upstream Face - The "Rock Paving" on the upstream face is exposed and appears to be in excellent condition. Rectangular rocks, four (4) to five (5) feet on a side and approximately two (2) feet thick, make up most of the cover of the upstream face. Smaller rocks fill the voids between these larger rocks. An attempt was made to dislodge a few of these smaller rocks by hand. In all cases, this was impossible. Weathering was apparent on the surfaces of a few of the larger rocks.

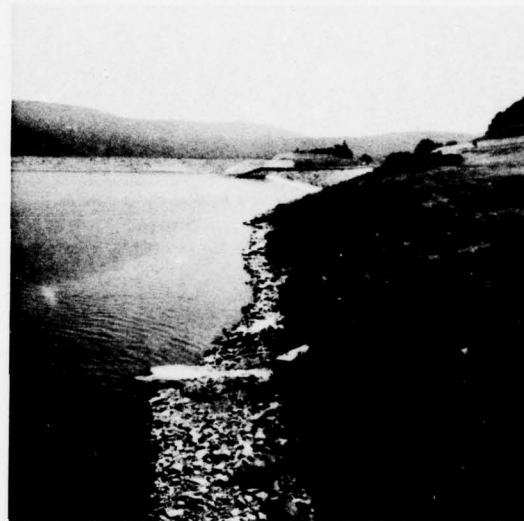
UPSTREAM FACE OF DAM, SPILLWAY AND
RIGHT BANK OF RESERVOIR

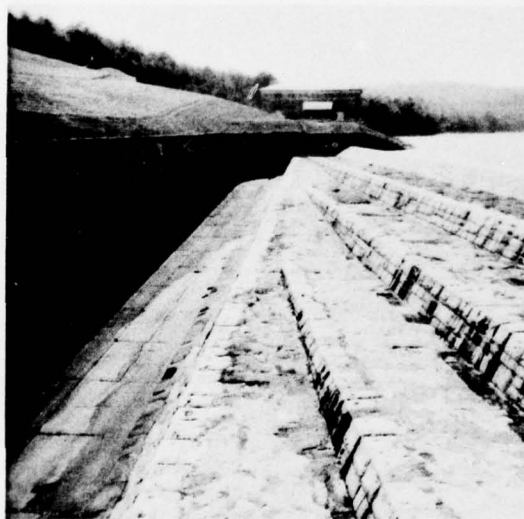
SIDE CHANNEL AND SPILLWAY

e. Overflow Spillway and Channel - The overflow spillway, channel and entrance to the discharge tunnel were examined from the top of the dam. No water was flowing over the spillway; therefore, the entire overflow structure, up to and including the tunnel entrance, was visible. The spillway, downstream channel and tunnel entrance appear to be in excellent condition with virtually no deterioration visible. There is minor seepage through the spillway about six (6) feet below the crest of the weir at the eastern end. The channel was clear and free of sediment or debris.

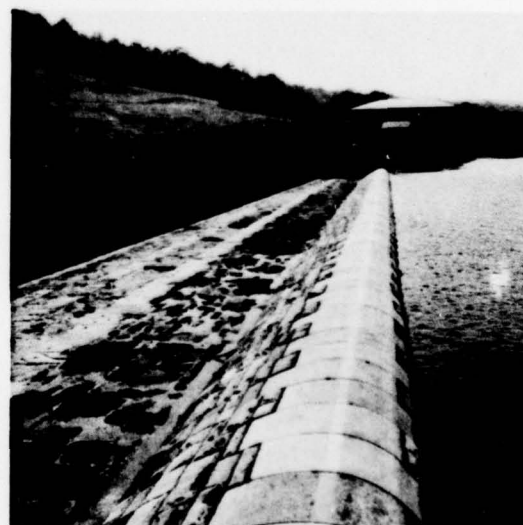
VIEW OF SPILLWAY

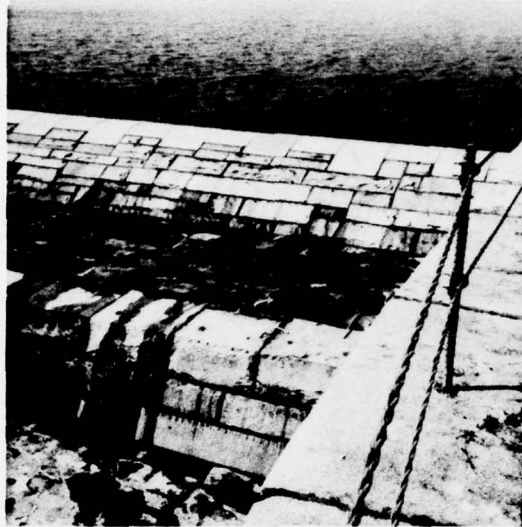
Minor seepage through the eastern end of the spillway was observed but should not affect the structural stability of the spillway section.

VISUAL EXAMINATION OF	OBSERVATIONS	REMARKS OR RECOMMENDATIONS
CUT STONE WEIR	Generally in excellent condition, minor seepage through the spillway approximately 6' below the crest near the eastern end.	Monitor seepage, insure that it does not increase. If increase occurs, make structural repairs.
APPROACH CHANNEL	Excellent condition.	None.
DISCHARGE CHANNEL A-8	Excellent condition. Well-maintained, free of debris, adequate to pass probable maximum flow.	None.
BRIDGE AND PIERS	None.	None.

SPILLWAY SHOWING SEEPAGE

2. Seepage through the eastern section of the spillway should be monitored; if the flow increases, remedial measures should be taken. A partial drawdown of the reservoir may be necessary to make the necessary repairs at the source of the flow.

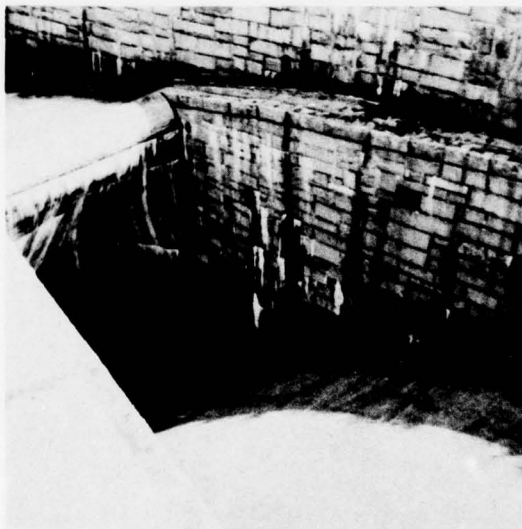
ENTRANCE TO TUNNEL AT DOWNSTREAM END OF CHANNEL
